Mobile Intel® Celeron® Processor at 466 MHz, 433 MHz, 400 MHz, 366 MHz, 333 MHz, 300 MHz, and 266 MHz Specification Update

Release Date: November 2002

Order Number: 244444-038

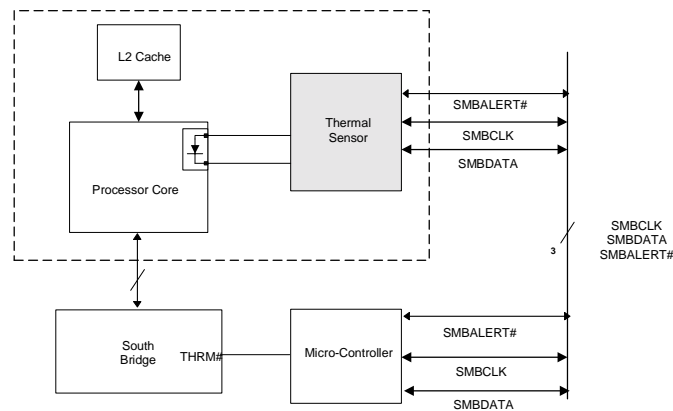
Figure 1. An Example of Microcontroller Driven Thermal Management

H29. Thermal Sensor May Assert SMBALERT# Incorrectly

Problem: The Intel Celeron Processor Mobile Module has a thermal sensor that monitors the processor core's temperature. Please note that desktop systems could have a similar thermal device. The thermal sensor asserts SMBALERT# if the processor temperature exceeds the temperature limits set in the Alarm Threshold Registers (T_{HIGH} , T_{LOW}). It also sets the corresponding Status Register bits to identify the cause of the interrupt. Figure 1 gives one example of the how the SMBALERT# signal could be used in a system.

Implication: There is no system impact from this erratum if temperature polling is used for processor thermal management. If the SMBALERT# interrupt is employed to manage processor thermal sensing, then servicing the false interrupt may result in premature system action depending on the software and hardware implementations used. The rate of the false interrupts is less than the auto-convert rate of the thermal sensor.

Workaround: Three different (mutually exclusive) workarounds are possible:

1. Before servicing an interrupt from the thermal sensor, read and compare the processor thermal reading with the threshold limits (T_{HIGH} or T_{LOW}). Figures 2 and 3 provide basic flowcharts for the implementation of this workaround in an interrupt driven system.
2. If the firmware implemented polls the Status Register only, then before taking any action, re-read the temperature register and do a comparison with the alarm threshold limits (T_{HIGH} or T_{LOW}) to determine if the value is actually still within the temperature window.
3. Use a temperature polling scheme to monitor the processor temperature.
